## Slope Erosion Prevention Techniques

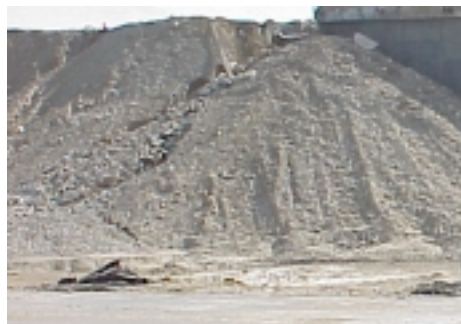
*Erosion damage due to untreated slope*

Left unchecked, erosion can increase project maintenance requirements, damage project aesthetics, jeopardize the structural integrity of project features, and pose a potential threat to water quality. Erosion control measures, incorporated into the project design or applied as a temporary BMP, minimize the opportunity for erosion impacts to develop.

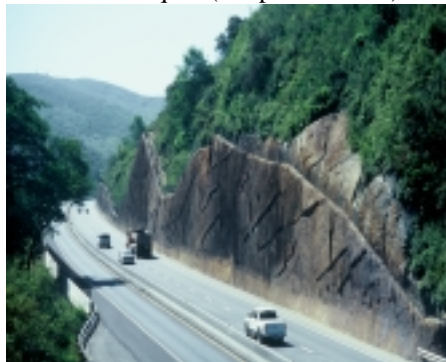
where the roadway design requires a significant cut into an existing hillside and slope lengths or steepness ( $>1:1.5$ ) are too great to deploy surficial erosion control techniques (see photo below).

*Retaining wall for slope cut stabilization and top of wall ditch for runoff control*

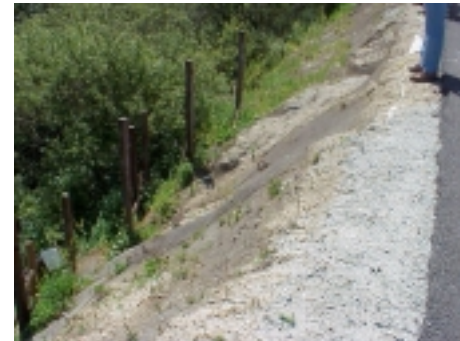
Erosion control measures such as hydroseeding, bonded fiber matrix, rolled plastic sheeting, blankets or geotextiles are not successful in areas where slopes are too steep ( $>1:1.5$ ), or in areas where runoff is not adequately controlled. Surficial techniques cannot be relied upon in areas where flow concentrations or gravitational forces overwhelm the

stabilization effects of the selected product. The Post Construction Inspection Team findings confirm that surficial solutions to roadside erosion problems are only successful when attention has been given to treatment of the underlying grade and control of stormwater runoff.

*Soil blanket on a steep hillside with uncontrolled runoff*

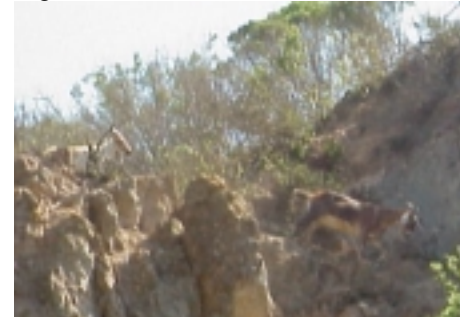
Additional factors can cause hillside soil loss despite the most conscientious application of structural and surficial erosion control measures. General slope failure, due to geotechnical rather than surficial instabilities, can cause "slip failure" of an entire hillside. Unstable soils, improper grading or off-site construction activities could be factors associated with this type of slope failure. In addition, livestock free to wander on properties abutting project right-of-way can seriously impact the effectiveness of vegetative or onsite measures.

*Livestock disruption of hillside stability*
